# RETROWRAP

## ANODE ENGINEERING

Arklow Bank, Southern Ireland  
Retrofit of Monopile in Splash zone and Subsea to Seabed

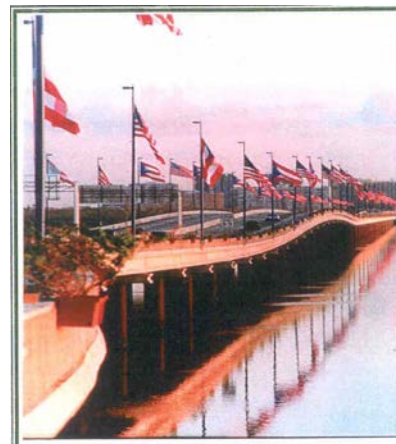
We initiated a new corrosion inspection monitoring program that started one year after the installation of the Retrowrap on our 409 piles. The inspection would include verification of CP, visual inspection of the coating above the jackets and periodic removal and inspection of a sample of jackets in the splash zone. We also installed 9 corrosion coupons to verify corrosion control in the sample. These coupons have an their exact weight recorded at 1/10,000 of a gram at regular intervals.

Results after one year were as follows. Corrosion monitoring coupons were removed at three different elevations on pile No. 1, row 34. Coupon No.1 had a metal loss equivalent to 0.2428 mil per year. Coupon No. 2 and No. 3 showed even less with 0.0648 and 0.0321 mil per year respectively.

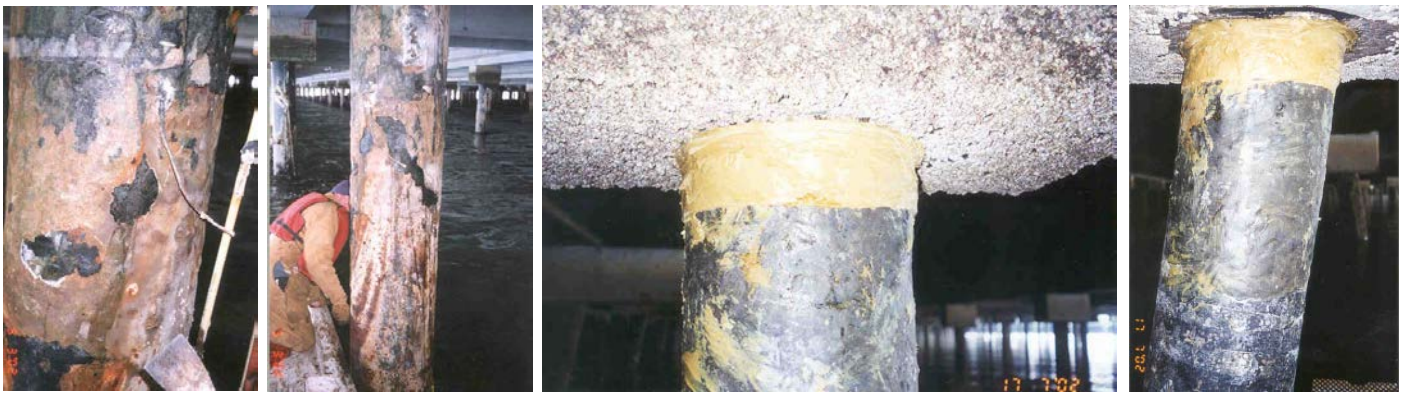
After damaged wrap removed, close up of blisters in existing epoxy visible.

Top seal installed on 16" pile, top seal installed on 16" batter pile.

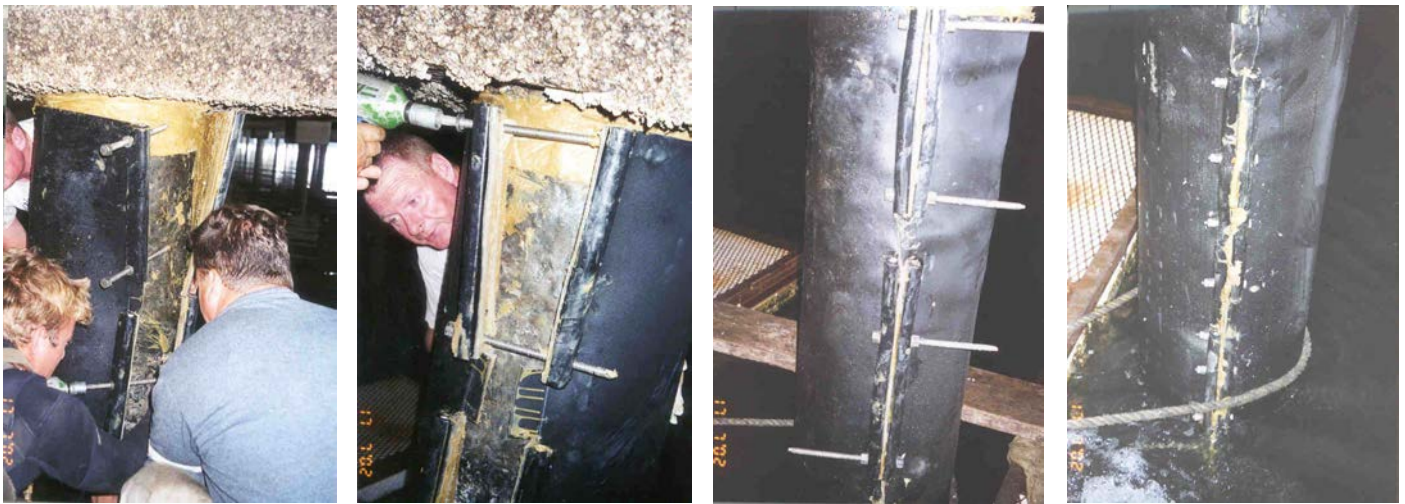
16" Retrowrap HD being secured into position.

Temporary bolts replaced with Class 2 SS316L bolts, fully installed.

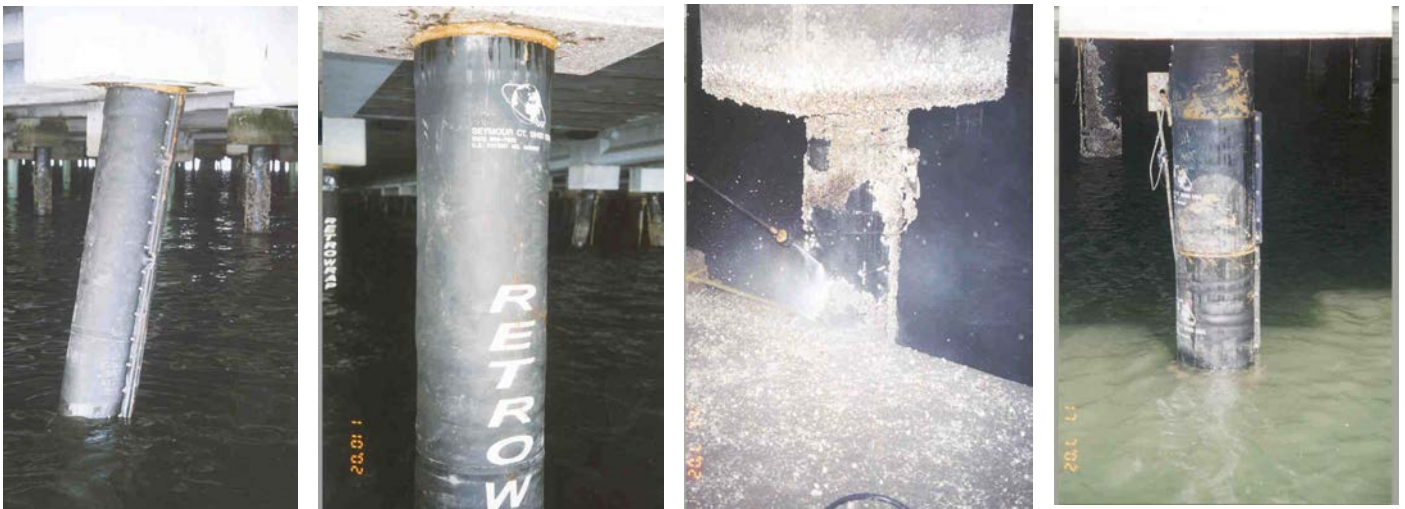
16" diameter batter pile showing outline of top seal in contact with underside of dock. Note top seal is forced against underside of pile due to hoop tension induced into fabric during installation.

Water jet removal of marine growth from damaged Denso wrap prior to fitting 18"x28" repair Retrowrap. Double repair over damaged Denso SeaShield.

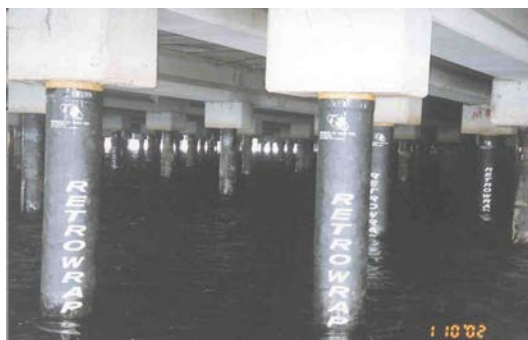
Impact and abrasion resistant Retrowrap HD retrofitted over piles where earlier installed wraps have been damaged.

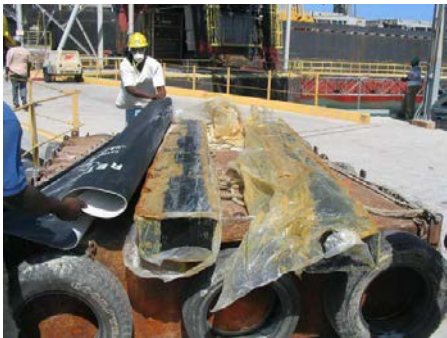
Retrowrap H Pile outer jacket with associated pre felted pre gelled filler blocks being loaded on work barge

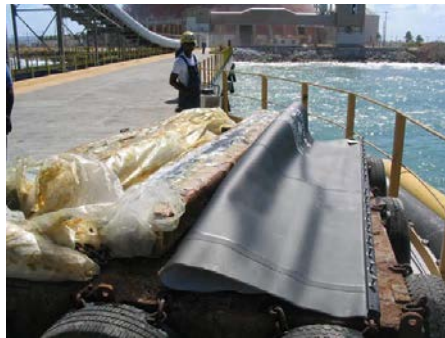
Full length one piece outer jacket with lag fasteners pre installed. Note Indent tag attached to jacket to ensure correct installation

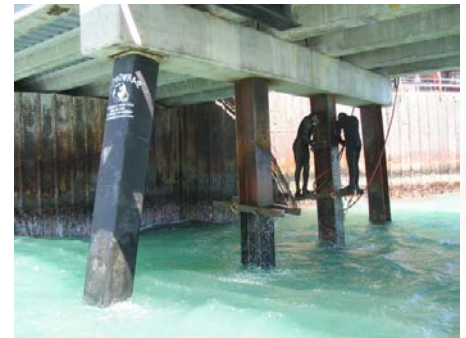
Temporary work platform attached to pile to permit upper pile cleaning and attachment of upper seal collar against pile cap

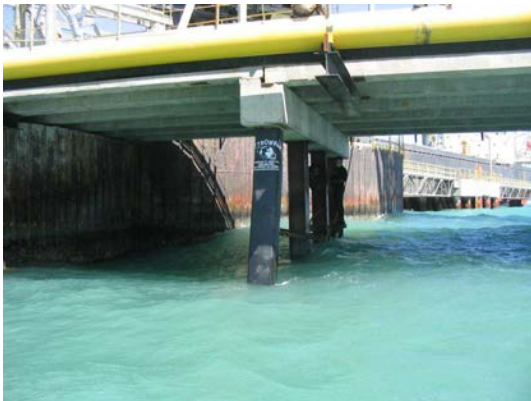
Full length outer jacket installed. Note Radius contour visible across pile flat face

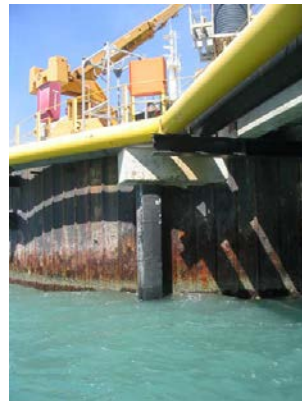
Jacket and filler blocks installed on 14" vertical and raker piles

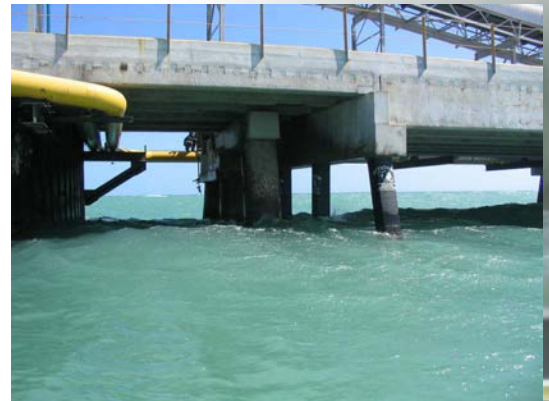
After hurricane Dean ripped through Jamaica in 2007, the concrete jetty was completely ripped from its H-beam piles. The Retrowrap system that was installed escaped untouched by the force of the hurricane with all wraps intact.

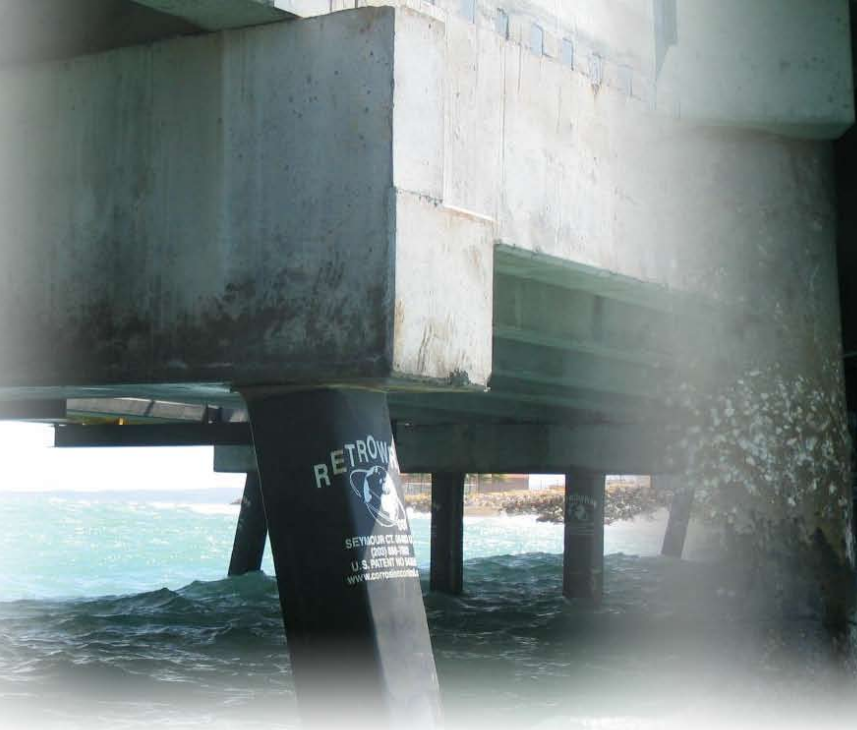
*Raker pile cap termination*

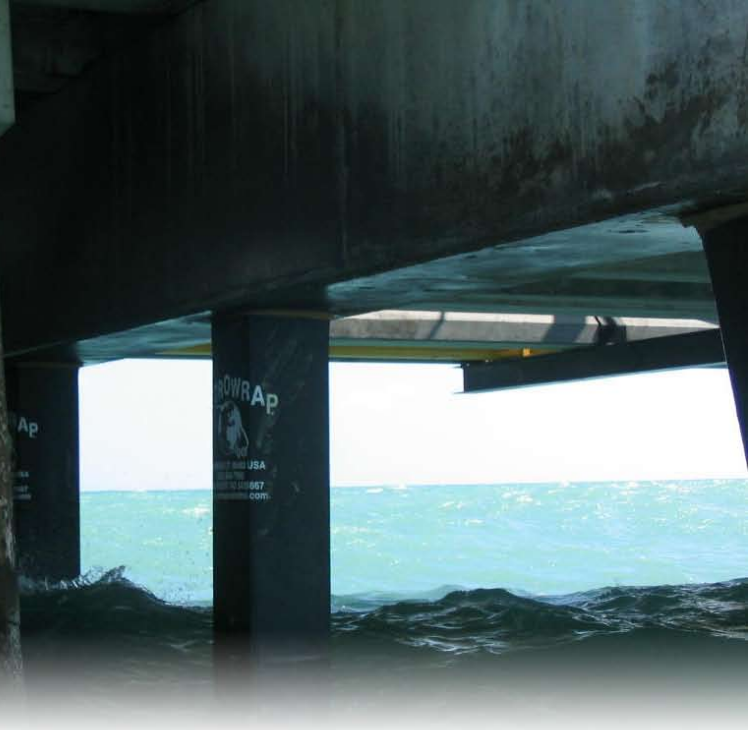
*Vertical pile cap termination*

*Vertical pile jacket showing outline (under fabric) of pile cap top seal seated at pile/  
pile cap high stress interface*
